**TEARDOWN REPORT  
OF TWO MODEL TPE331-10T-515K TURBOPROP ENGINES  
SERIAL NUMBER P-79297C AND P-79001C**

**October 8, 2014**

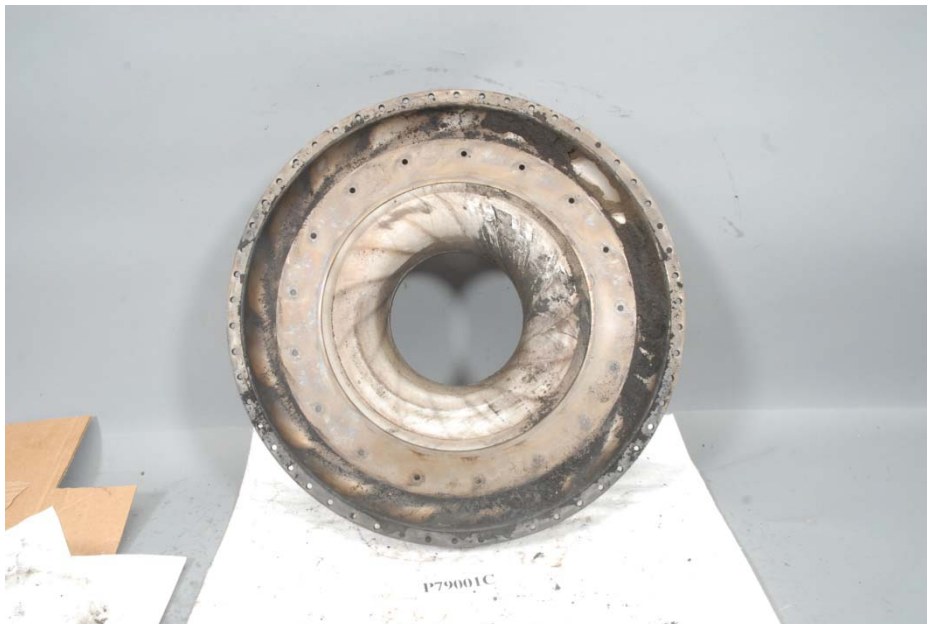
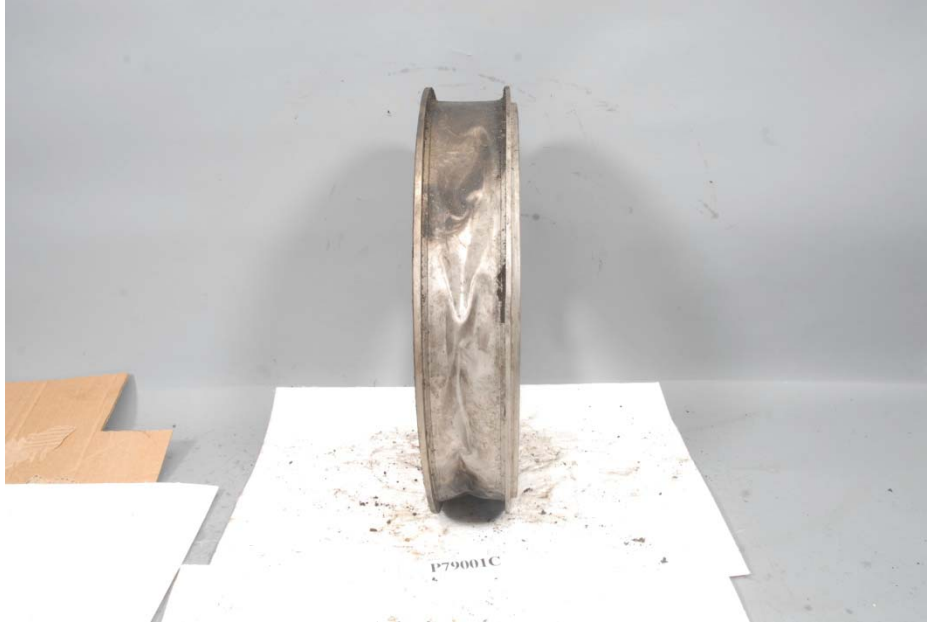
- (f) Second-Stage Compressor Housing: (Figure 309 and Figure 310)
- The second-stage compressor housing was intact.
  - The second-stage compressor housing displayed compression wrinkles (axial damage). (Figure 311)

**Figure 309.** P-79001C, Second-Stage Compressor Housing, FLA

**Figure 310.** P-79001C, Second-Stage Compressor Housing, ALF

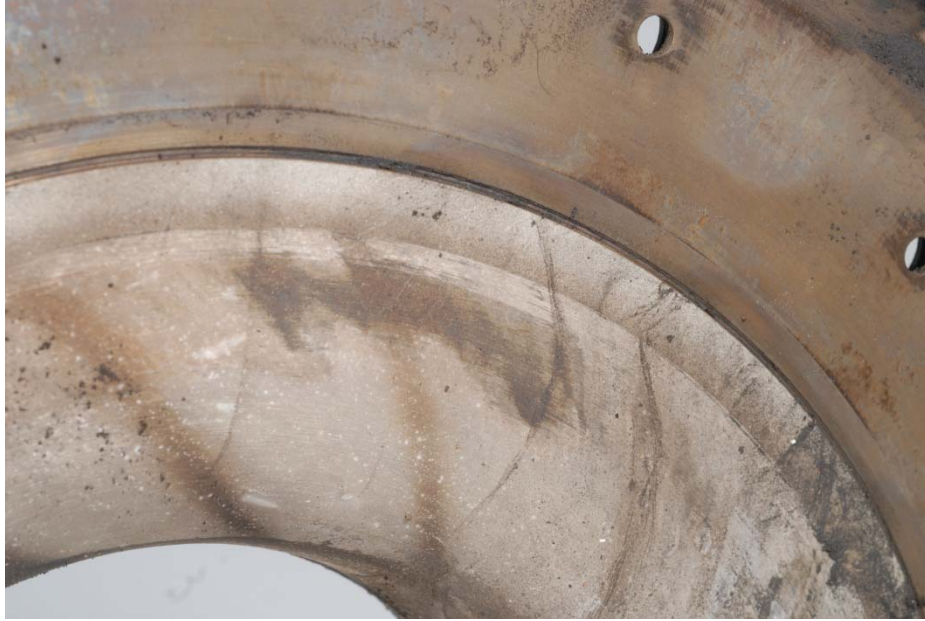
- The second-stage compressor housing was covered with black soot debris on the external surfaces.
  - The second-stage compressor housing contained earthen debris adhering to the flow path surfaces of the transition area. (Figure 312)

**Figure 312.** P-79001C, Second-Stage Compressor Housing, Earthen Debris

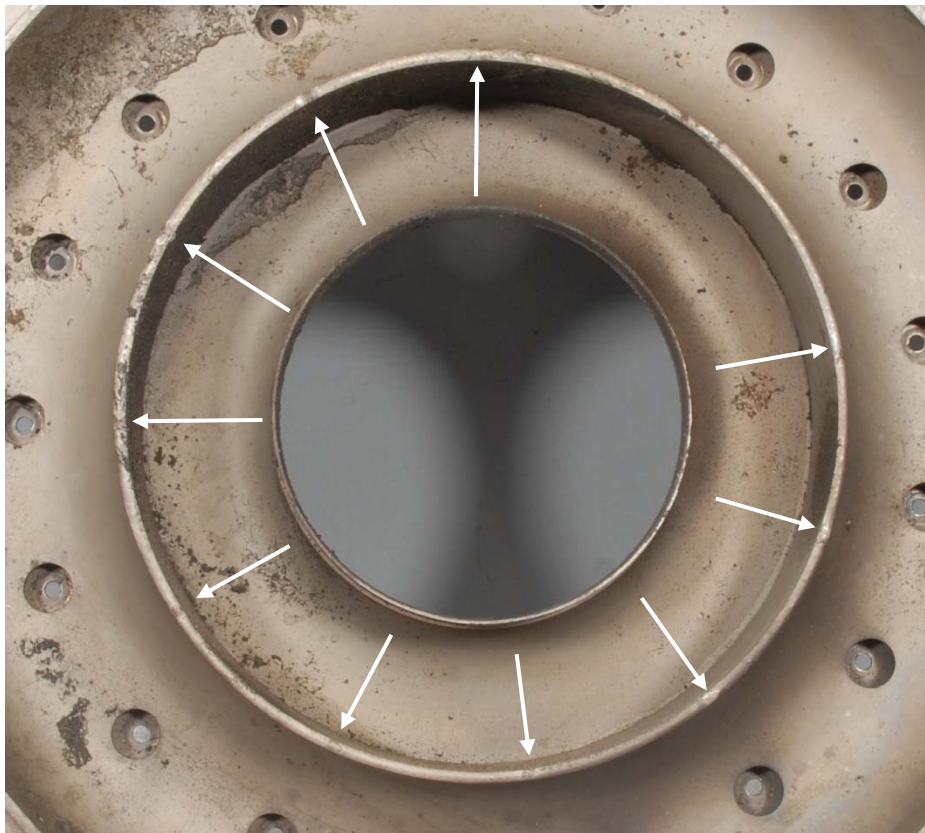
**Figure 313.** P-79001C, Second-Stage Compressor Housing, Shroud Rub

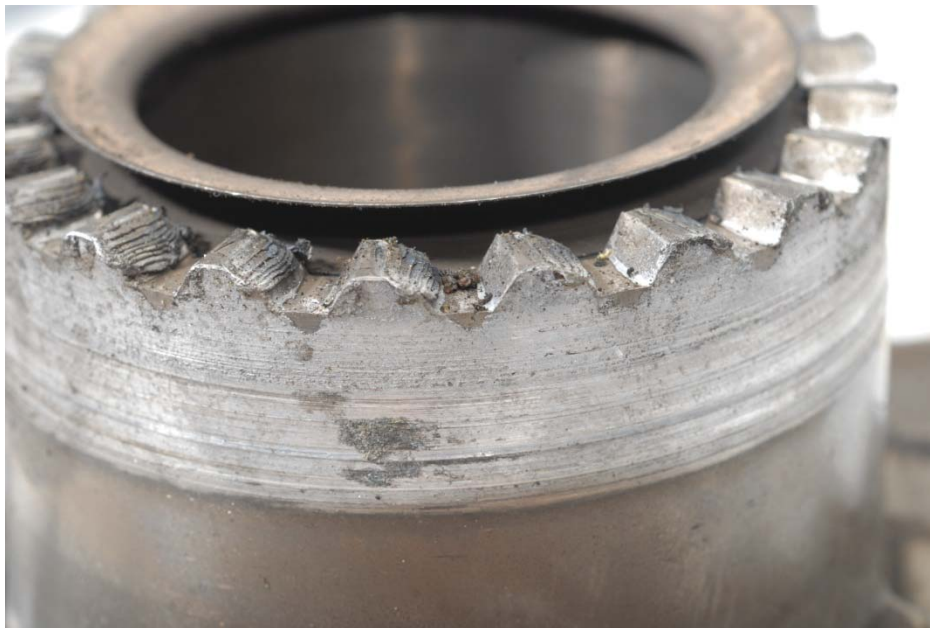
**Figure 317.** P-79001C, Second-Stage Compressor Impeller, Shroud Line Edge Rotational Scoring

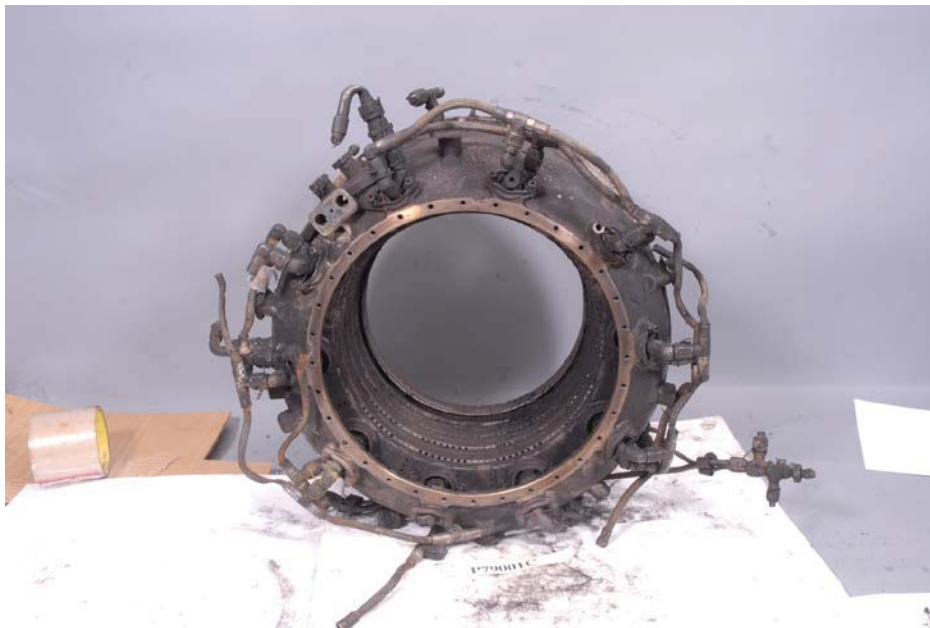
**Figure 321.** P-79001C Second-Stage Compressor Diffuser Vane Assembly, Earthen Debris

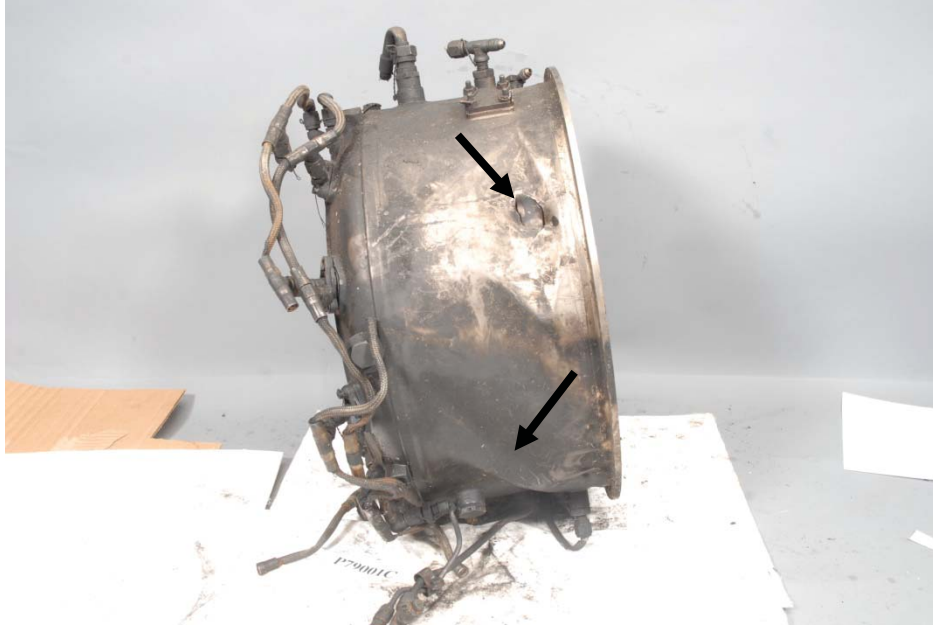
- There was black debris, consistent with soot, adhering to the external surface of the combustor plenum case. (Figure 324)
  - The combustor plenum case was dented and punctured at the 3 o'clock position and displayed compression wrinkles (axial damage). (Figure 325)

**Figure 324.** P-79001C, Combustor Plenum Case

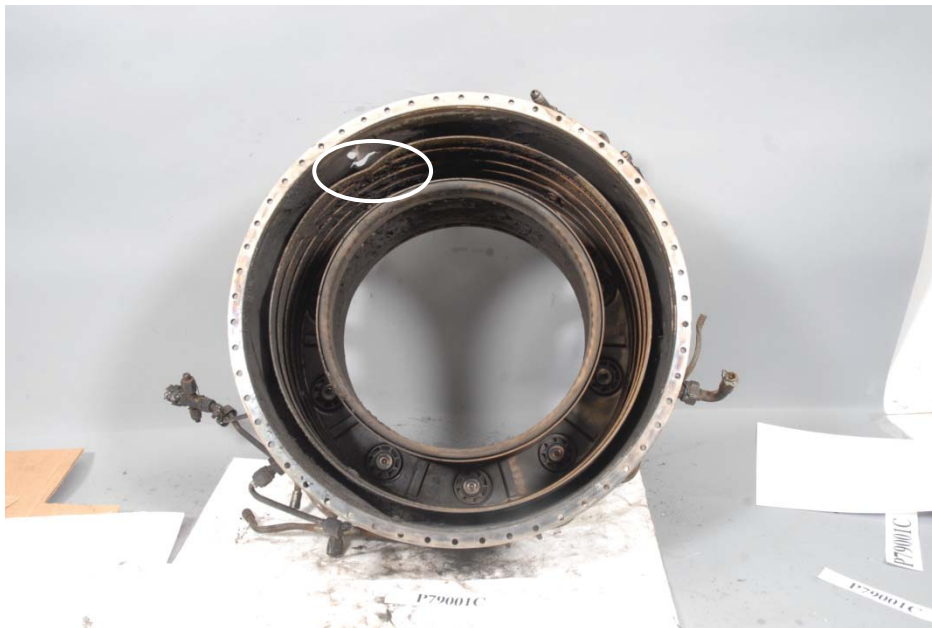
- (c) De-swirl Vane Assembly: (Figure 326)
- The de-swirl vane assembly was intact.
  - The de-swirl vane assembly had earthen debris adhering to the surfaces of all vanes. (Figure 327)

**Figure 327.** P-79001C, De-swirl Vane Assembly, Earthen Debris

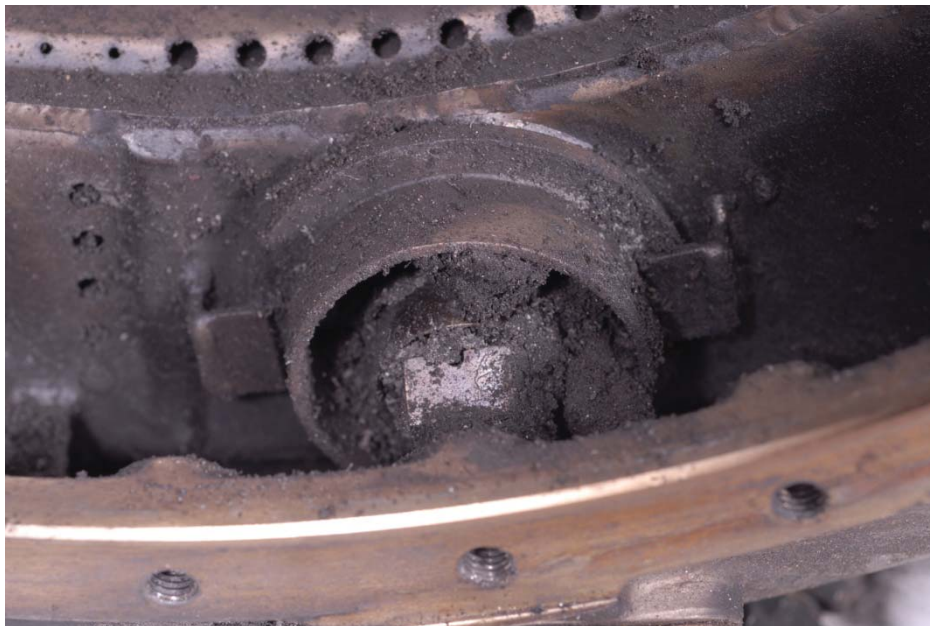
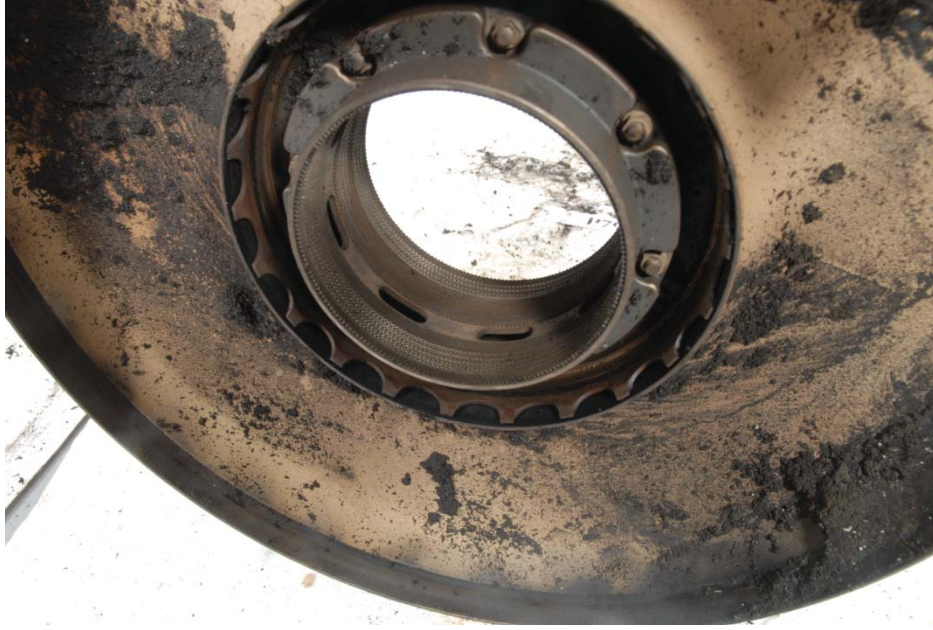
- (d) Combustion Chamber:
- The combustion chamber was intact, but was dented in the area adjacent to dent/puncture on the plenum. (Figure 328)
  - There was earthen debris adhering to the outer liner surfaces of the combustion chamber. (Figure 329 and Figure 330)

**Figure 329.** P-79001C, Combustion Chamber, Earthen Debris

**Figure 330.** P-79001C, Combustion Chamber, Earthen Debris

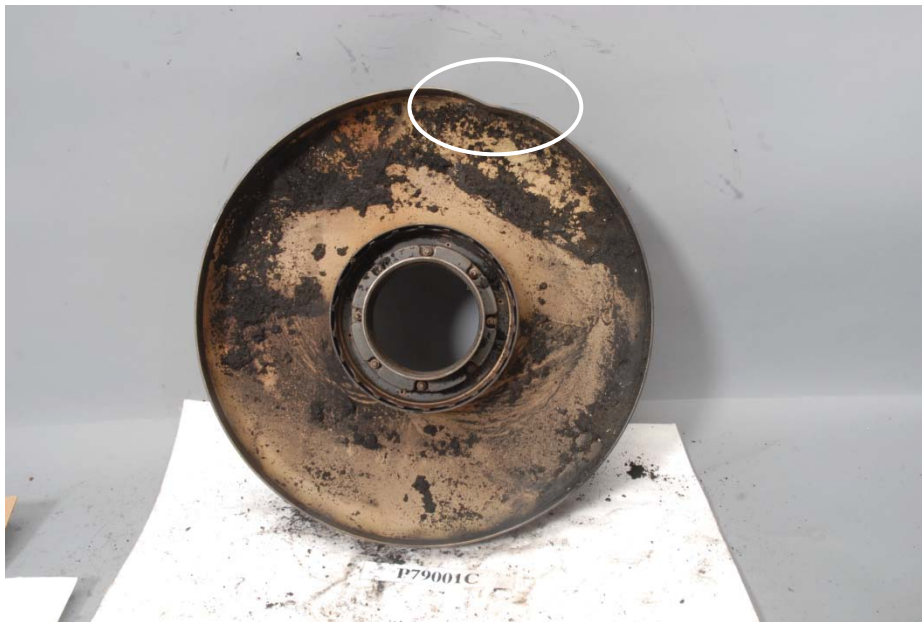
- There was earthen debris adhering to the inner surfaces of the outer transition liner. (Figure 331)
  - The outer transition liner displayed impact damage adjacent to the impact damage on the plenum. (Figure 332)

**Figure 331.** P-79001C, Outer Transition Liner, Earthen Debris

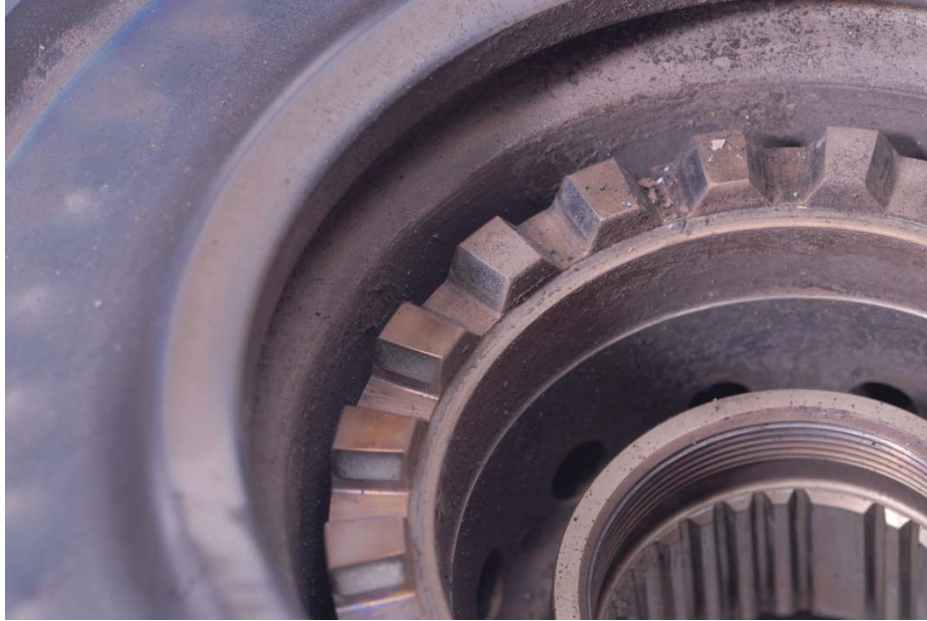
- (a) Center Curvic Coupling: (Figure 333)
- The center curvic coupling was intact.
  - The center curvic coupling knife seals were slightly worn.
  - The center curvic forward coupling teeth were moderately damaged. (Figure 334)
  - The center curvic aft coupling teeth appeared to be undamaged. (Figure 335)

**Figure 334.** P-79001C, Center Curvic Coupling, Forward Curvic

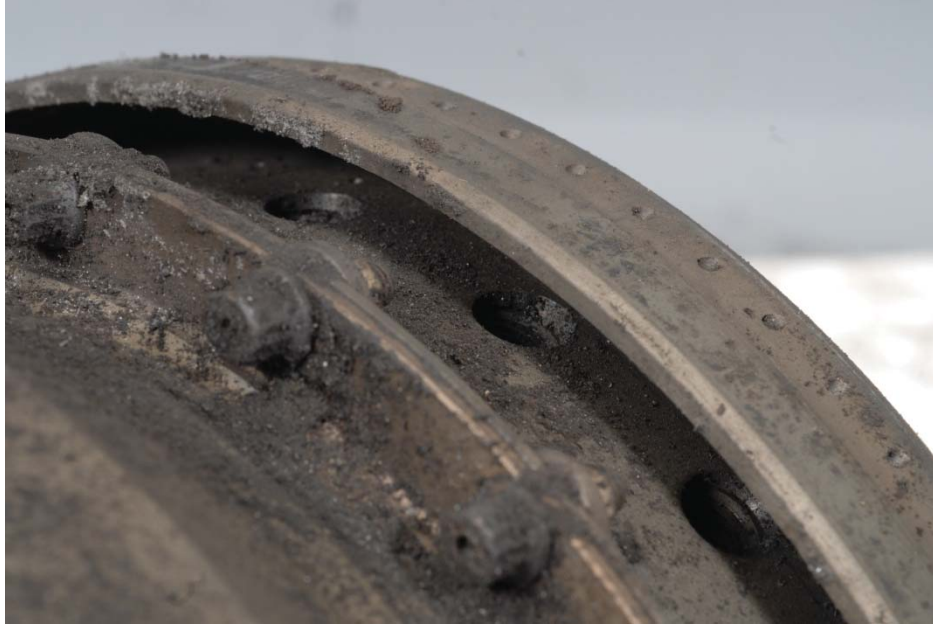
- There were compressor-shroud metal spray deposits on the suction side of the first-stage turbine stator vanes. (Figure 338)
  - There was dirt located in several cooling holes of the inner transition liner of the first-stage turbine stator. (Figure 339)

**Figure 338.** P-79001C, First-Stage Turbine Stator Assembly, Earthen Debris and Metal Spray Deposits

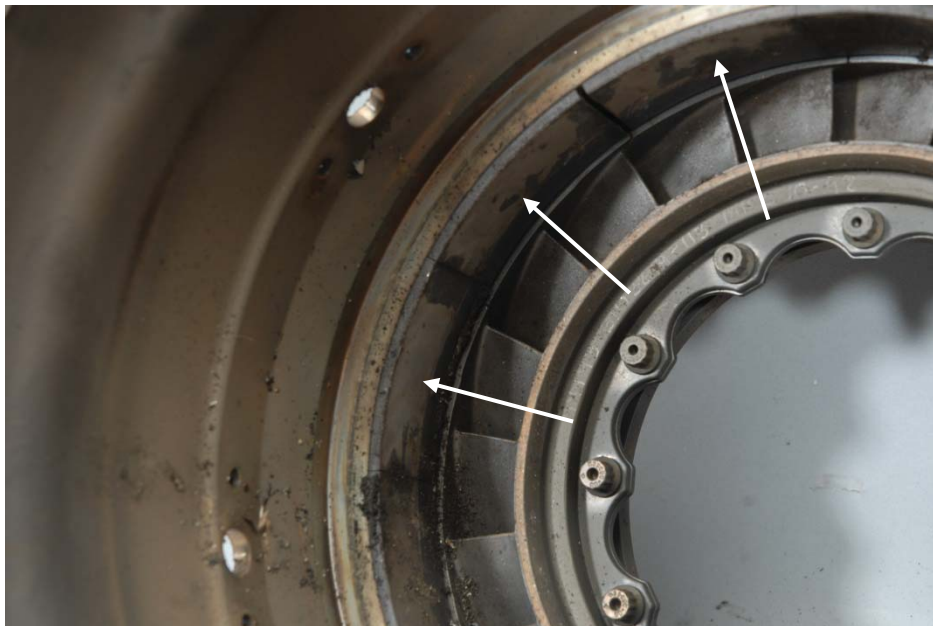
**Figure 339.** P-79001C, First-Stage Turbine Stator Assembly, Earthen Debris

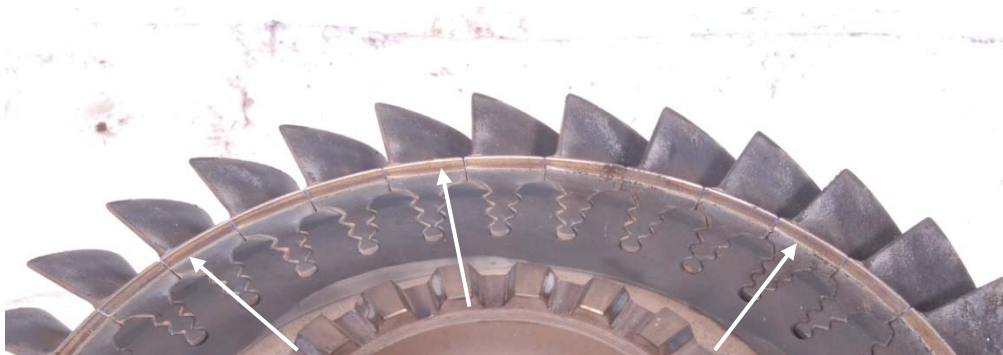
- (c) First-Stage Turbine Rotor: (Figure 341 and Figure 342)
- Part Number: 3101520-3
  - Serial Number: 98032-2900362
  - Lot Number: LN99-P112
  - The first-stage turbine rotor displayed rotational scoring on the shroud line edge of all blade tips (Figure 343) with corresponding rotational scoring on the first-stage turbine blade tip shroud.

**Figure 343.** P-79001C, First-Stage Turbine Rotor, Blade Tip Rotational Scoring

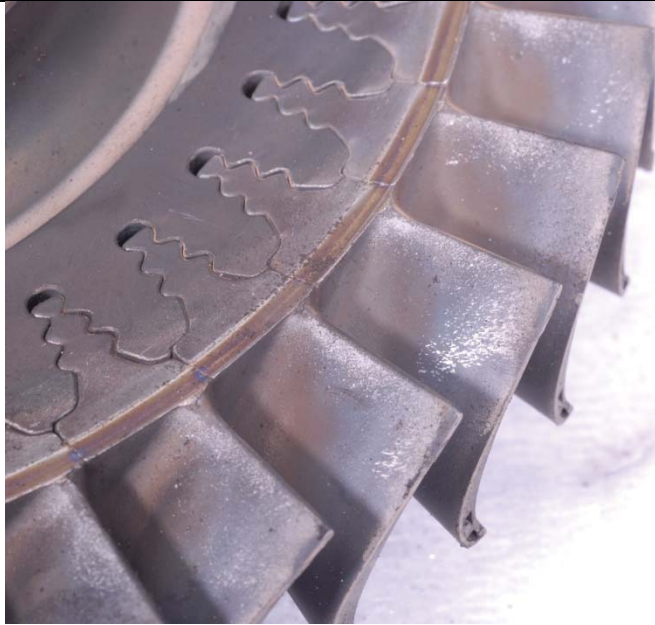
- The first-stage turbine rotor displayed rotational scoring on the aft blade platforms (Figure 344) with corresponding scoring to the forward inner vane support for the second-stage stator.

**Figure 344.** P-79001C, First-Stage Turbine Rotor, Rotational Scoring

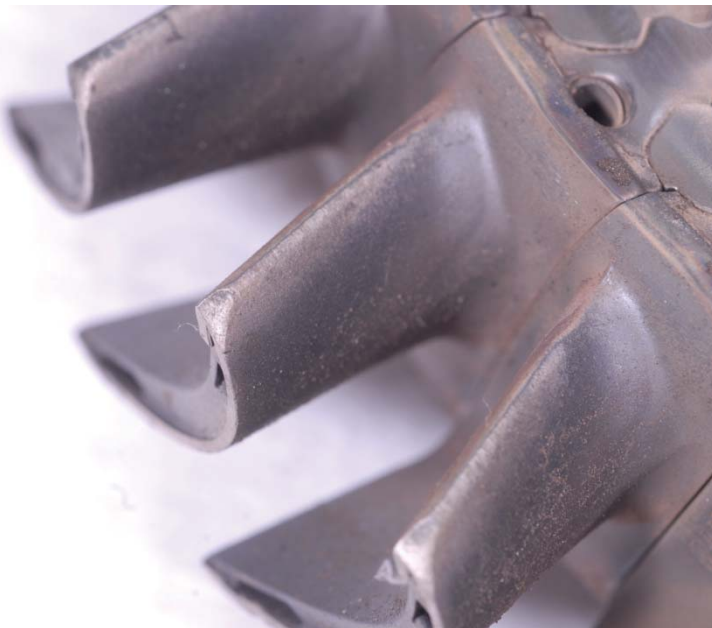
- There were compressor-shroud metal spray deposits on the suction side of the first-stage turbine rotor blades. (Figure 345)
  - The leading edge tips of the first-stage turbine rotor blades showed signs of erosion. (Figure 346)

**Figure 345.** P-79001C, First-Stage Turbine Rotor, Metal Spray Deposits

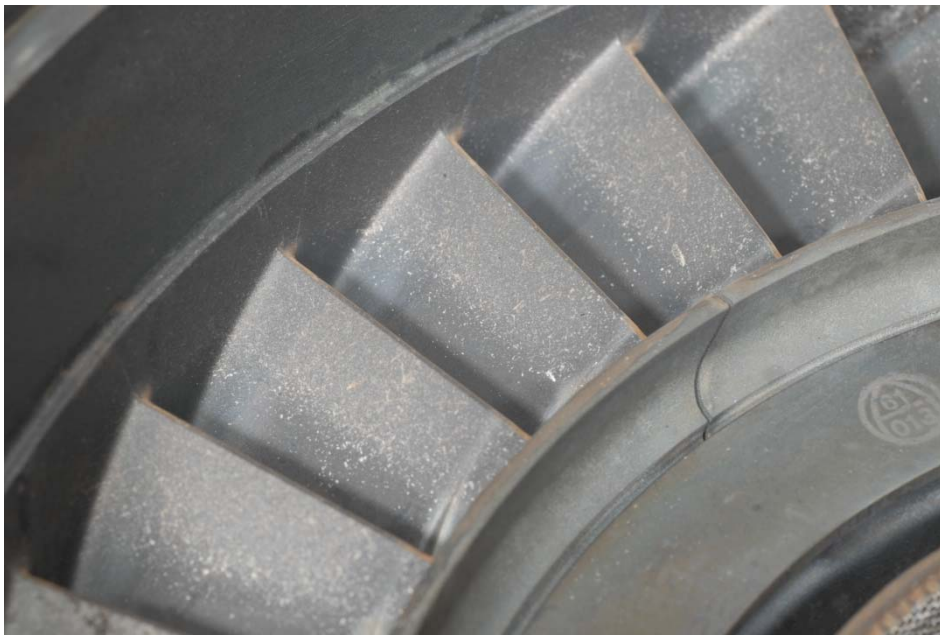
- The second-stage turbine stator was intact.
  - There were compressor-shroud metal spray deposits on the leading edge and outer platform of the second-stage turbine stator vanes. (Figure 349)

**Figure 349.** P-79001C, Second-Stage Turbine Stator, Metal Spray Deposits

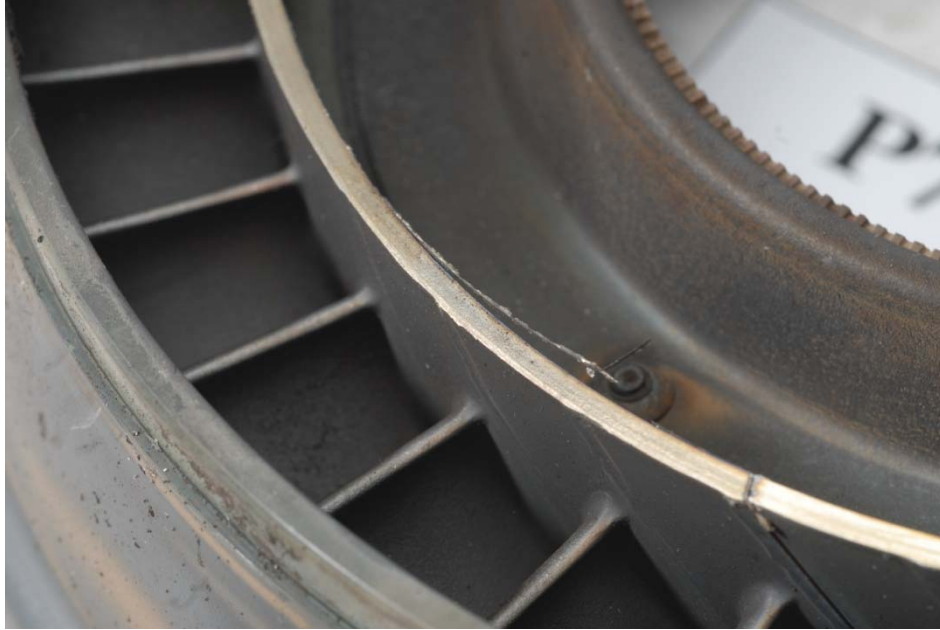
- There were compressor-shroud metal spray deposits on the suction side of the second-stage turbine stator vanes. (Figure 350)
  - The second-stage turbine stator displayed rotational score marks on the forward face of the inner vane support (Figure 351) with corresponding score marks on the aft face of the first-stage turbine wheel blade platforms.

**Figure 350.** P-79001C, Second-Stage Turbine Stator, Metal Spray Deposits

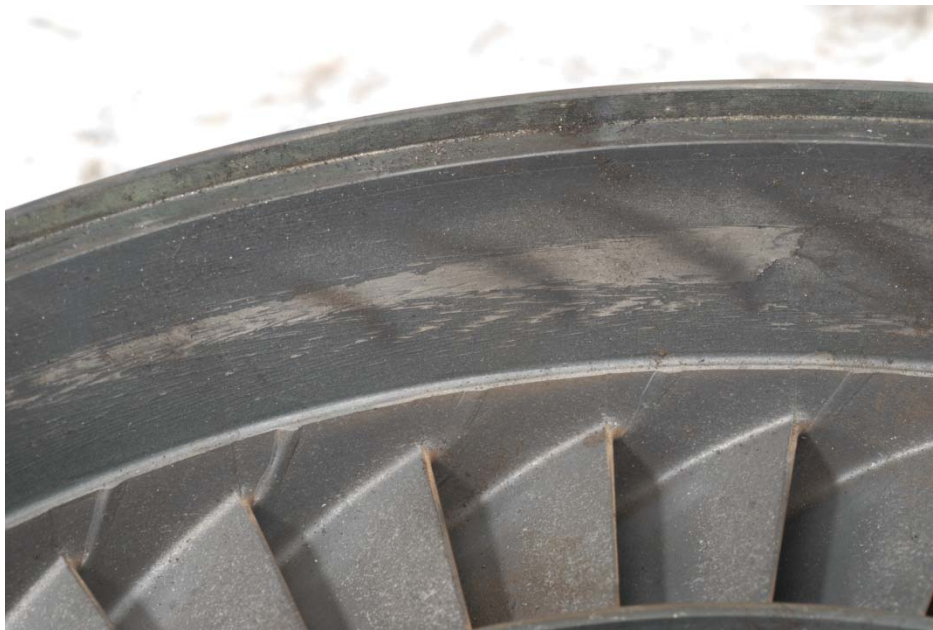
**Figure 351.** P-79001C, Second-Stage Turbine Stator, Rotational Scoring

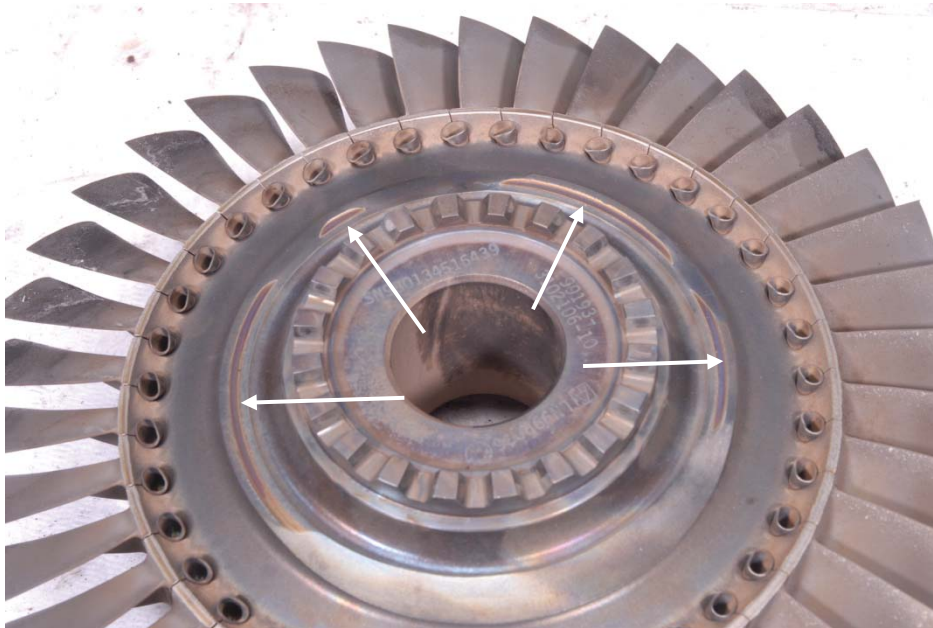
- Part Number: 3102106-10
  - Serial Number: 98013-4516439
  - Lot Number: 99-P2036
  - The second-stage turbine rotor displayed rotational scoring on the aft blade platforms (Figure 355) with corresponding scoring to the forward inner vane support for the third-stage stator.

**Figure 355.** P-79001C, Second-Stage Turbine Rotor, Rotational Scoring

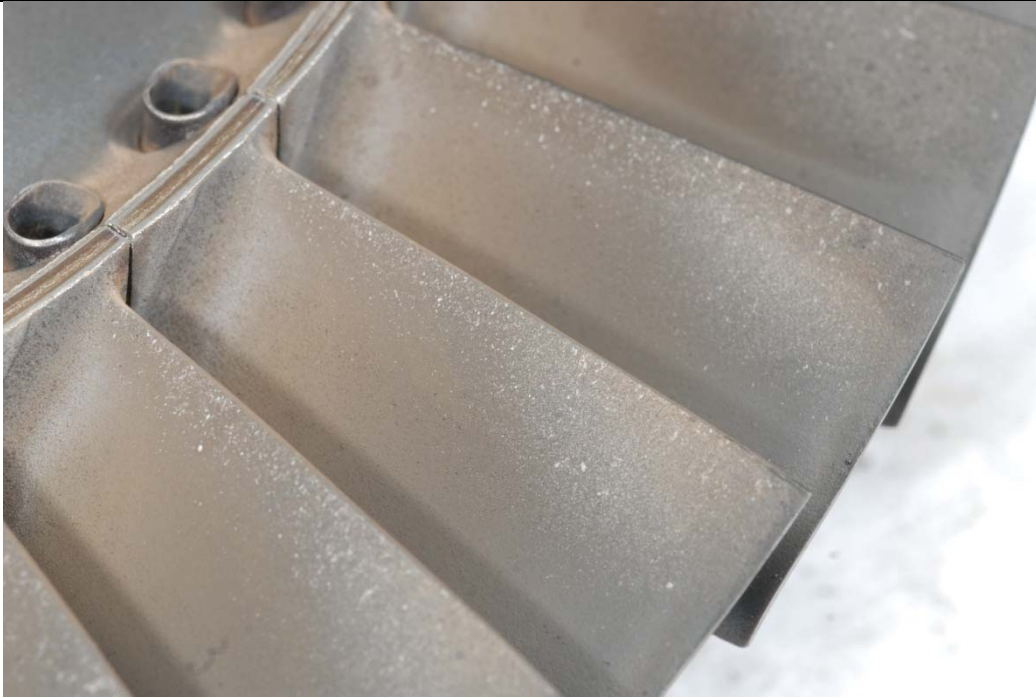
- The second-stage turbine rotor displayed rotational scoring on the aft hub face (Figure 356) with corresponding scoring to the forward inner vane support for the third-stage stator.

**Figure 356.** P-79001C, Second-Stage Turbine Rotor, Rotational Scoring

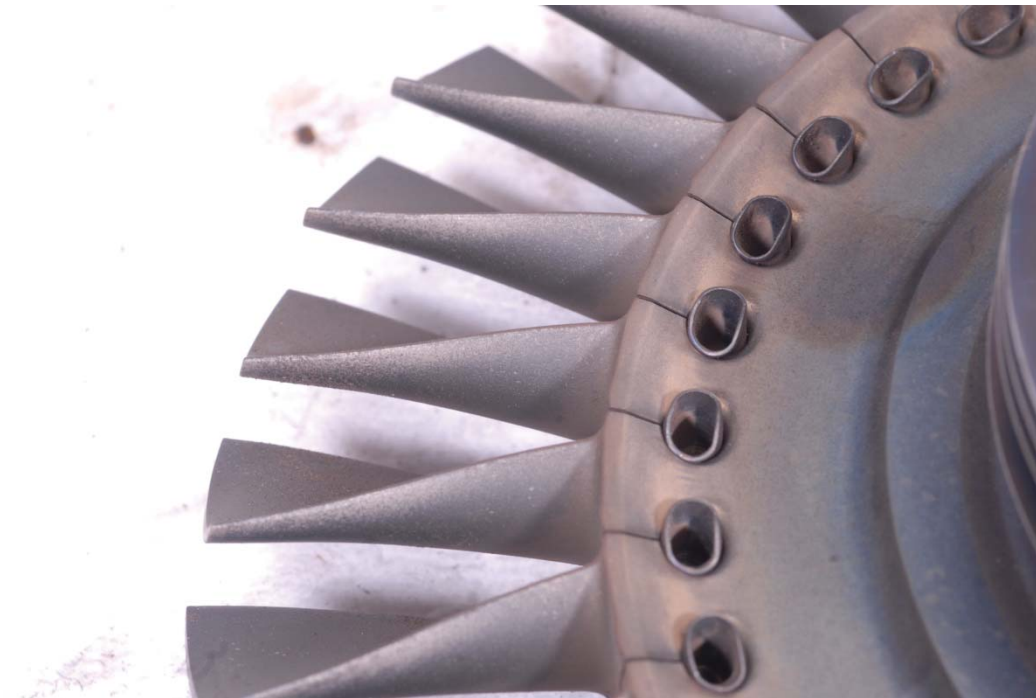
- There were compressor-shroud metal spray deposits on the suction side of the second-stage turbine rotor blades. (Figure 357)
  - There were compressor-shroud metal spray deposits on the leading edge of the second-stage turbine rotor blades. (Figure 358)

**Figure 357.** P-79001C, Second-Stage Turbine Rotor, Metal Spray Deposits

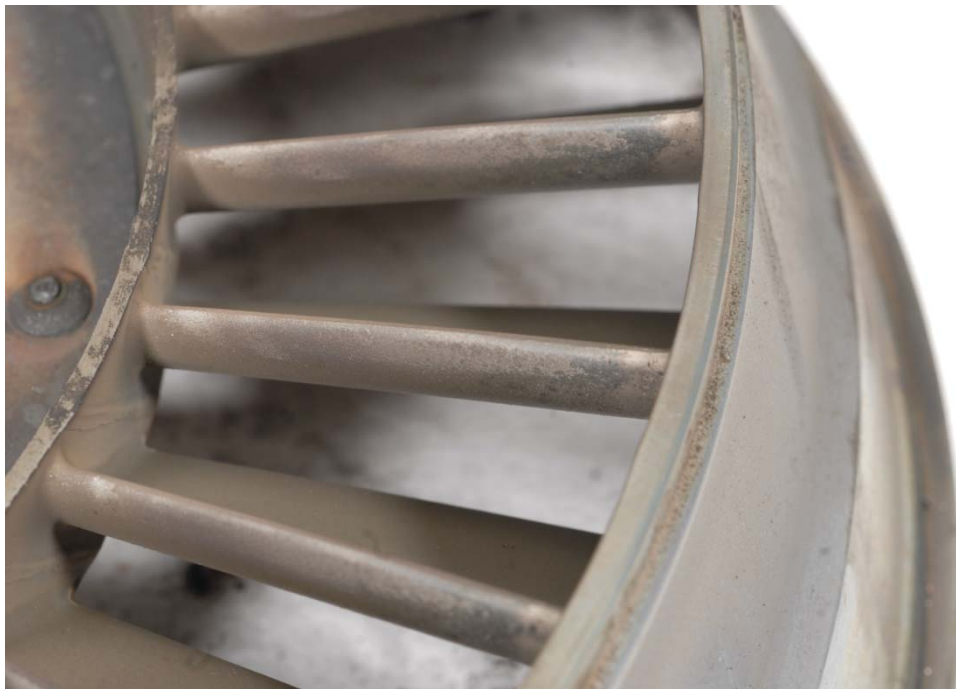
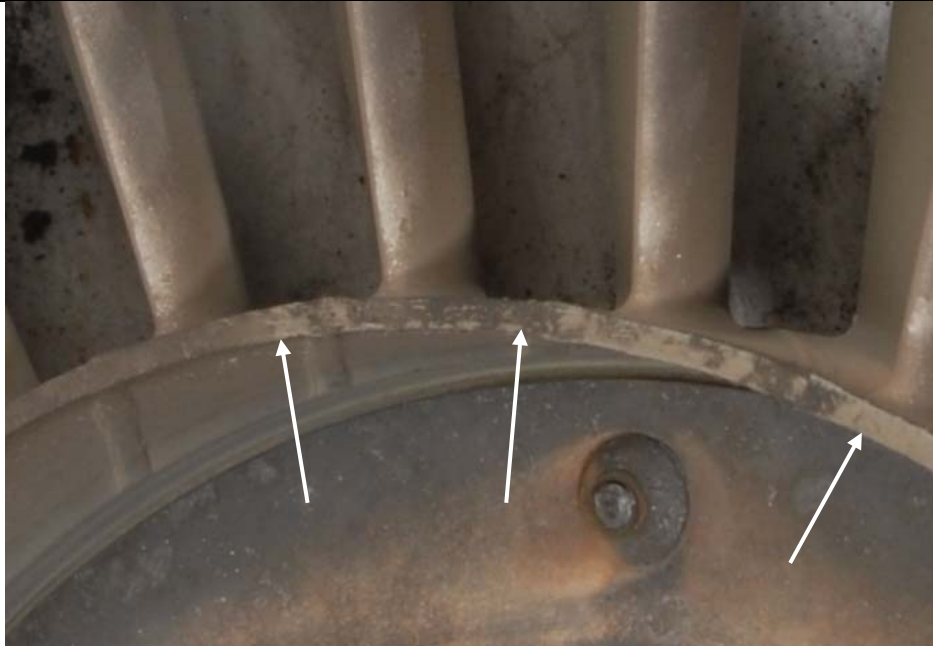
**Figure 361.** P-79001C, Third-Stage Turbine Stator, Metal Spray Deposits

**Figure 362.** P-79001C, Third-Stage Turbine Stator, Metal Spray Deposits

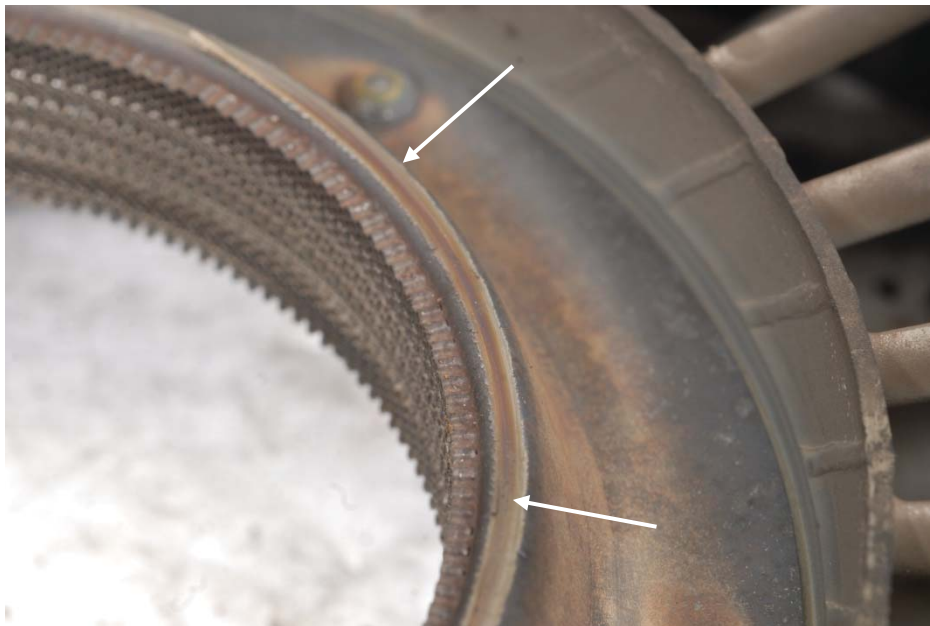
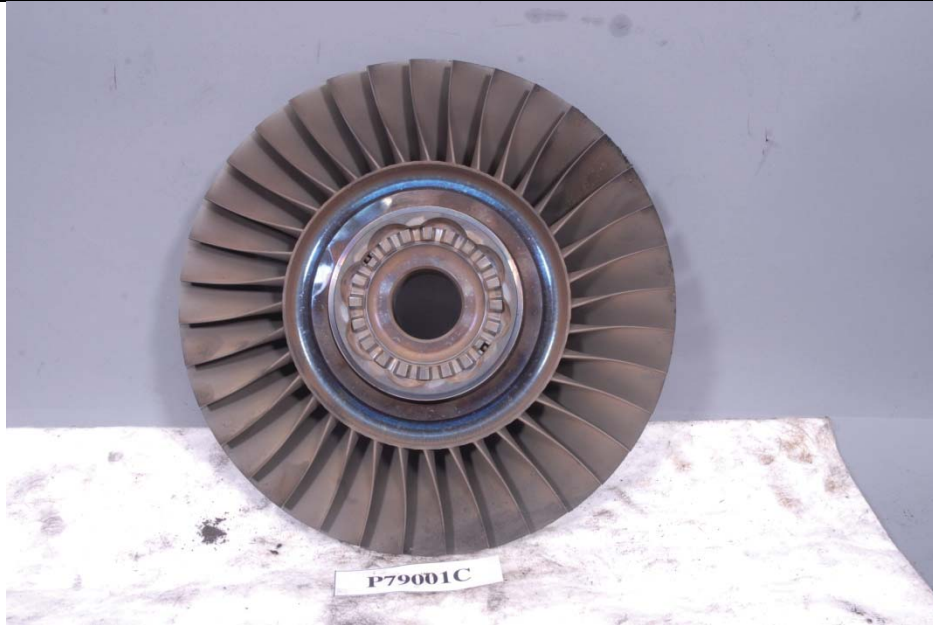
**Figure 363.** P-79001C, Third-Stage Turbine Stator, Rotational Scoring

**Figure 364.** P-79001C, Third-Stage Turbine Stator, Rotational Scoring

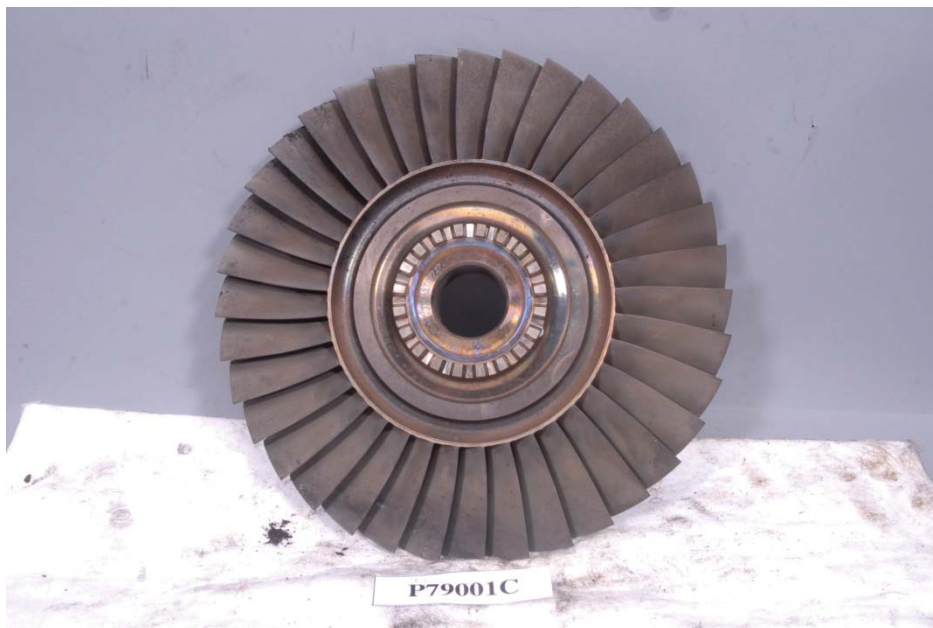
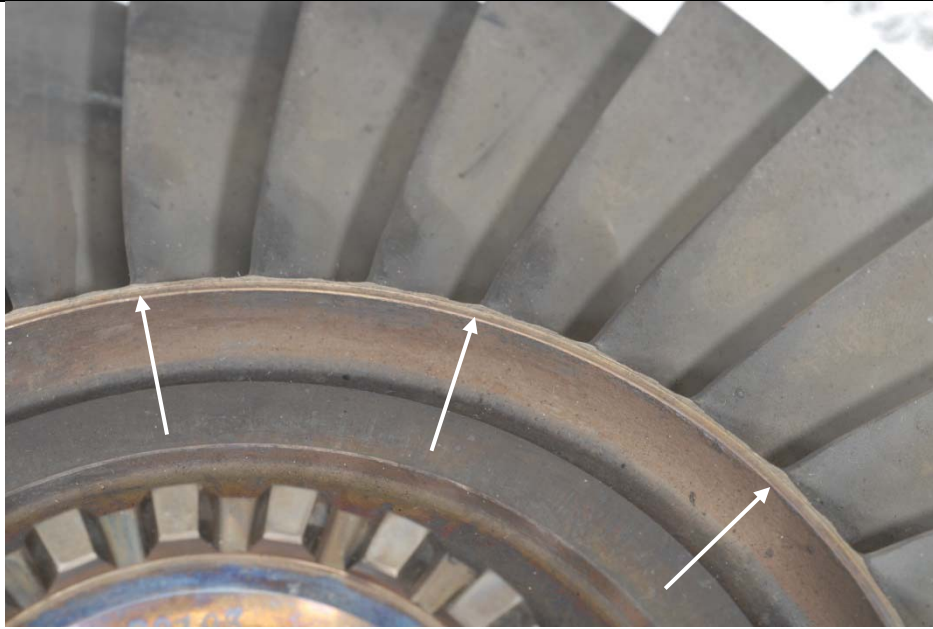
**Figure 365. P-79001C, Third-Stage Turbine Rotor, FLA**

- The third-stage turbine blade tip shroud appeared to be undamaged except for normal superficial rubbing.
- (g) Third-Stage Turbine Rotor: (Figure 365 and Figure 366)

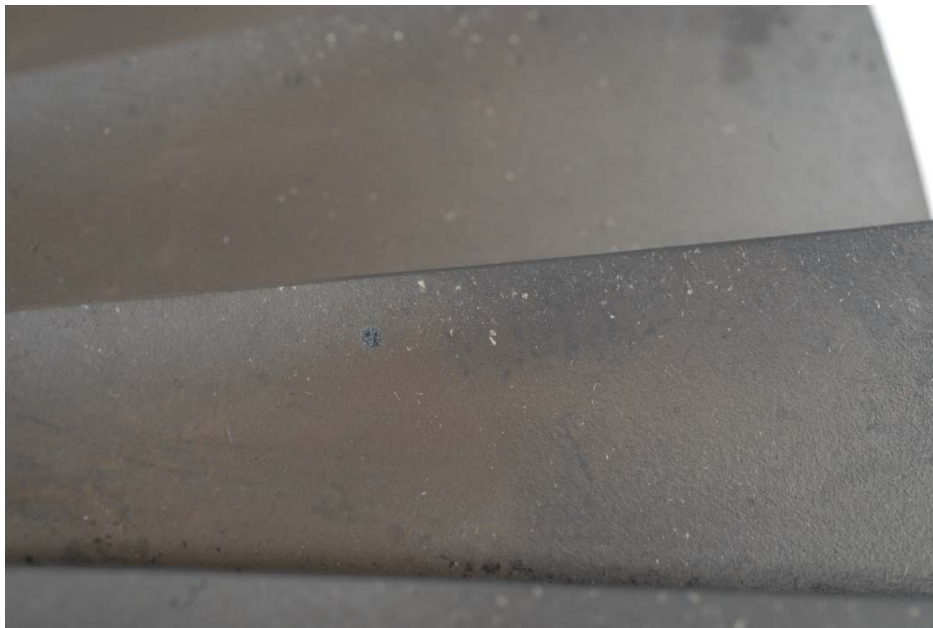
- Part Number: 3102655-2
  - Serial Number: 98013-4503727
  - Lot Number: 98-P122
  - The third-stage turbine rotor displayed rotational scoring on the aft blade platforms (Figure 367) with corresponding scoring to the forward face on the inner housing of the rear bearing support.

**Figure 367.** P-79001C, Third-Stage Turbine Rotor, Rotational Scoring

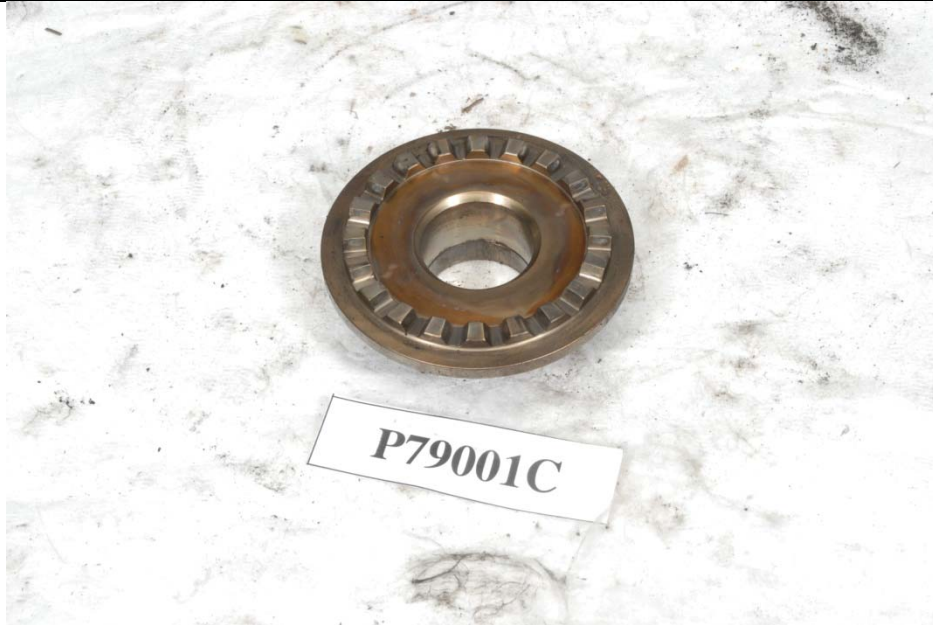
- The third-stage turbine rotor had compressor-shroud metal spray deposits on the suction side of the blades. (Figure 368)
  - The forward curvic teeth of the third-stage turbine rotor appeared to be undamaged.

**Figure 368.** P-79001C, Third-Stage Turbine Rotor, Metal Spray Deposits

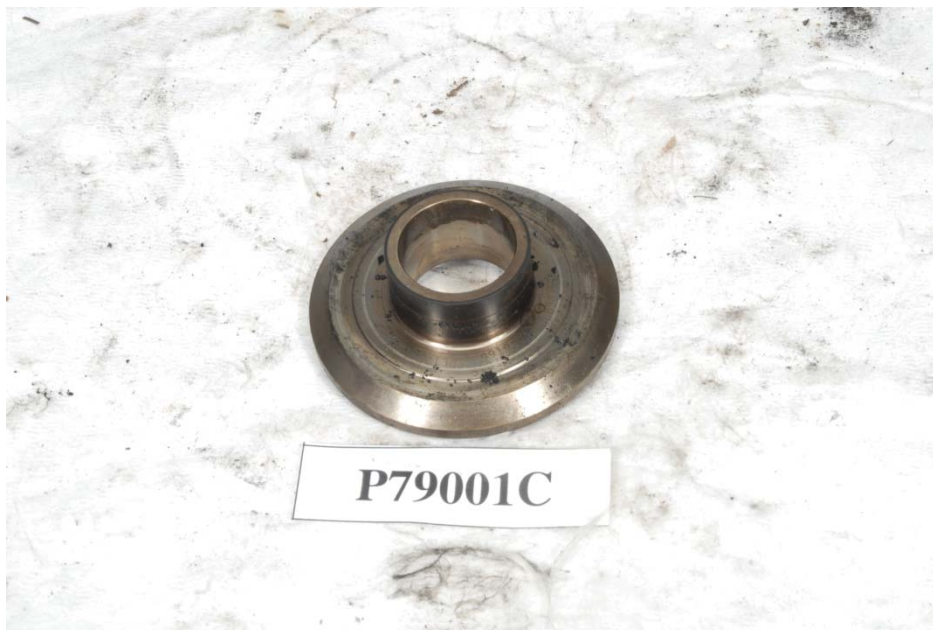
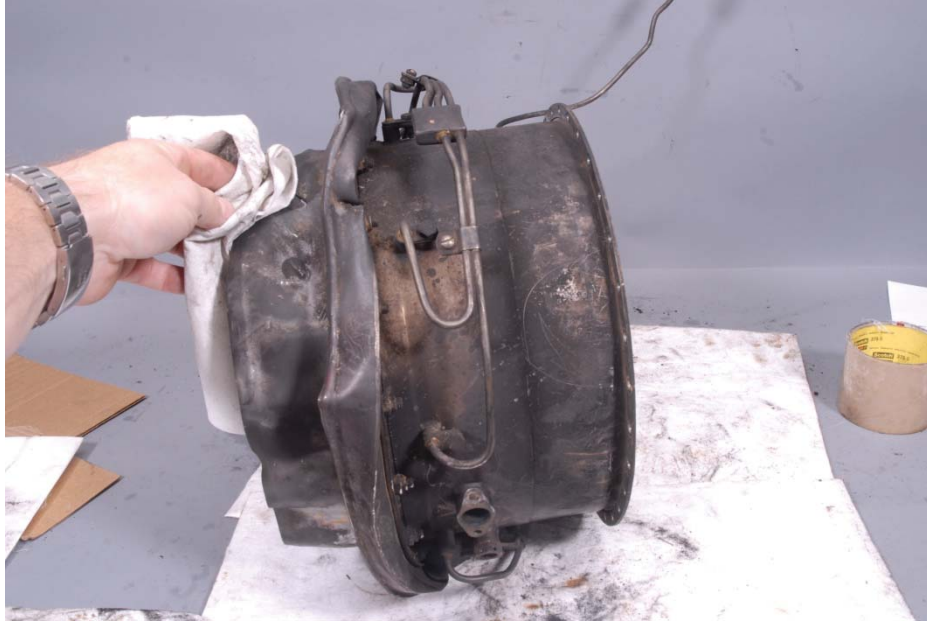
**Figure 369.** P-79001C, Rear Curvic Coupling, FLA

- The aft curvic teeth of the third-stage turbine rotor appeared to be undamaged.
- (h) Rear Curvic Coupling: (Figure 369 and Figure 370)
- The rear curvic coupling appeared to be undamaged.

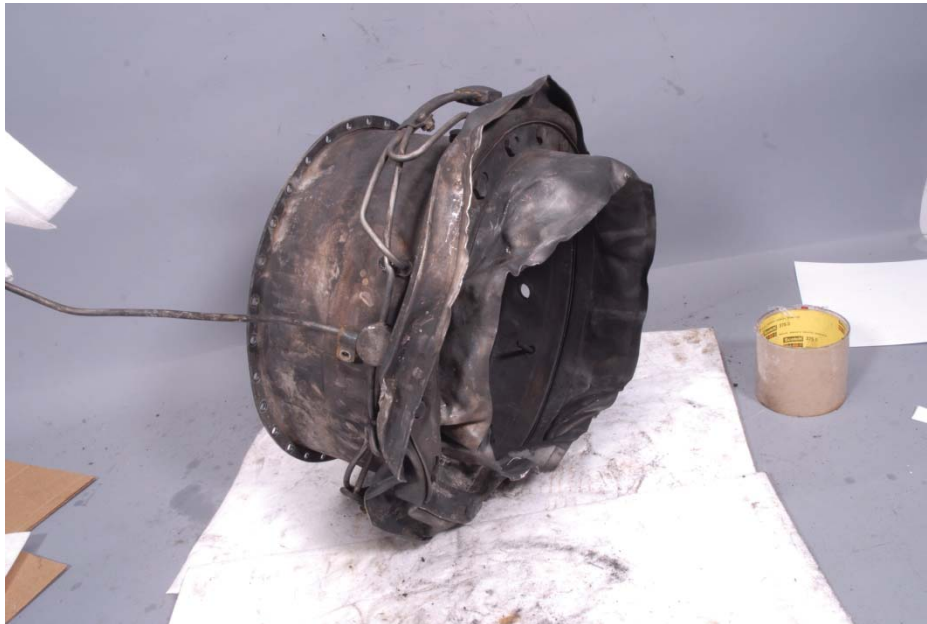
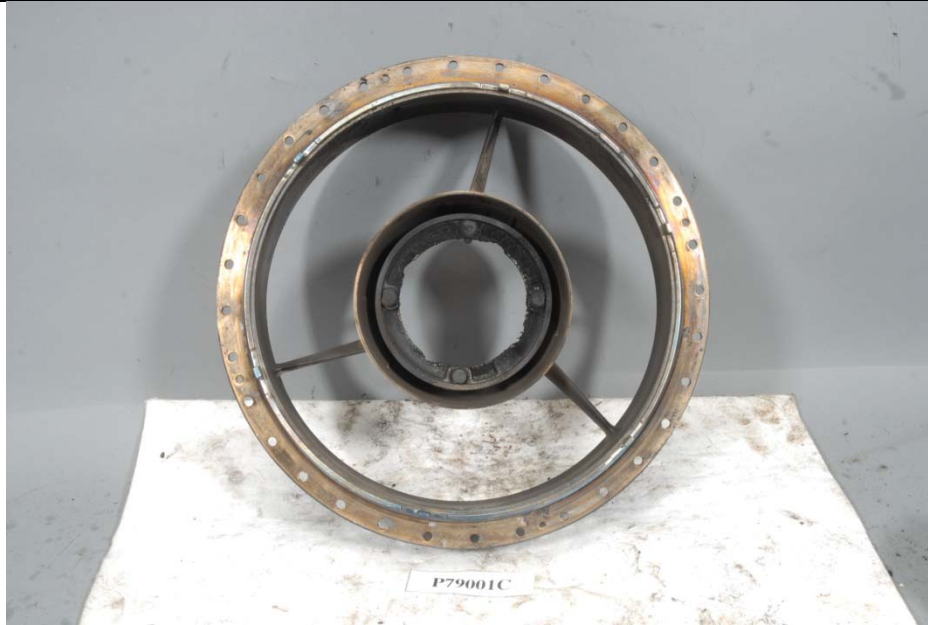
**Figure 371.** P-79001C, Engine Exhaust Duct and Thermocouple Harness Assembly

- (i) Engine Exhaust Duct: (Figure 371 and Figure 372)
- The engine exhaust duct was heavily buckled and crushed.
- (j) Thermocouple Harness Assembly:
- The thermocouple harness electrical connector was fractured from the harness and not returned with the engine.

- The thermocouple harness assembly was impact damaged and crushed with the engine exhaust duct.
- (k) Turbine Bearing Support Housing: (Figure 373 and Figure 374)
